# Chehalis Basin Strategy

Phase 2 Site Characterization

Technical Memorandum

Reducing Flood Damage and  
Restoring Aquatic Species Habitat

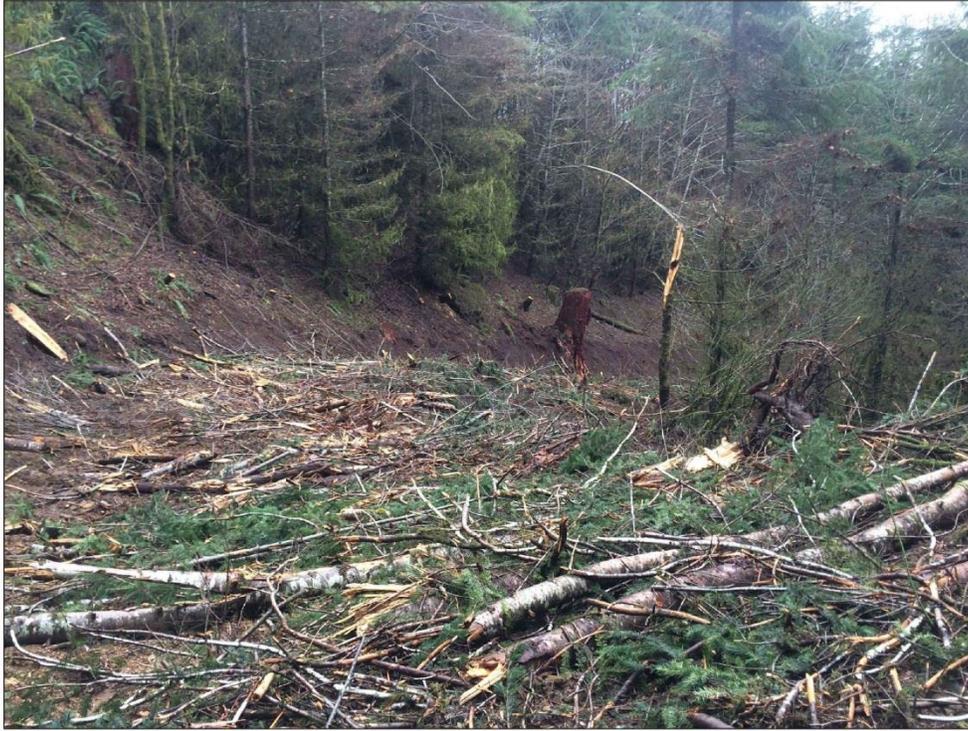
**Photograph 3.1**  
**Corduroy Road Surface for Borehole Location Access**

Located on Weyerhaeuser property, the borehole locations were accessed from Weyerhaeuser roads, the City of Pe Ell's water access road, and temporary pioneer access roads. John J. Karnas Co. (Karnas) was subcontracted to construct the pioneer roads prior to the start of the subsurface exploration program activities. Prior to building the roads, the trees within the approved road right of way were purchased from Weyerhaeuser, cut by Karnas, and left on site. Karnas used an excavator to create the pioneer roads. To make the roads passable in wet areas, Karnas created a corduroy road surface made from the trees cleared for the road construction (Photograph 3.1).

To restore the pioneer roads, Weyerhaeuser requested that the corduroy surface be left in place as erosion control. Water bars were placed every 100 feet in gentle slope area and every 50 feet on the steeper slopes. Straw and seed were spread over areas with exposed soil. Karnas finished the restoration of the pioneer roads after the subsurface explorations were completed.

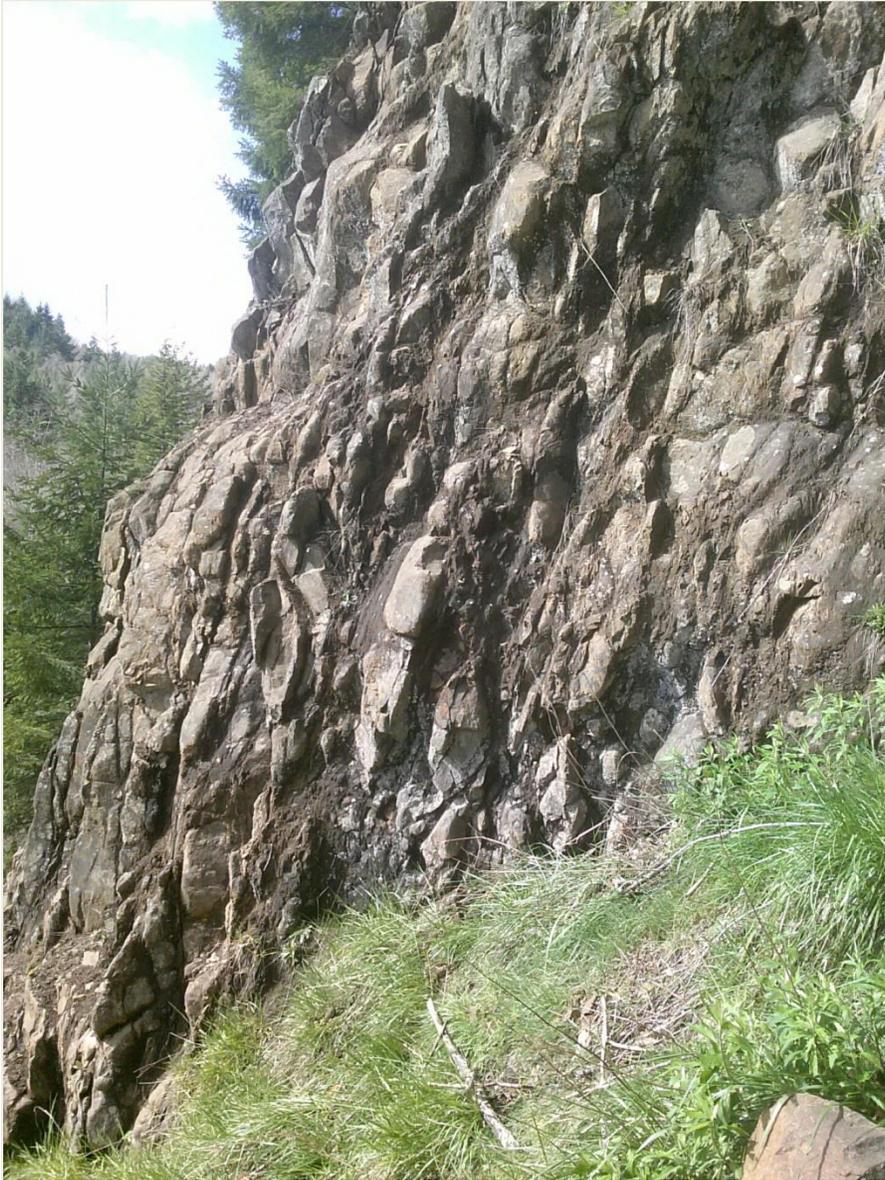
**Photograph 4.2**

**Outcrop 3, Upstream of the Dam and on the Eastern Bank of the Chehalis River**

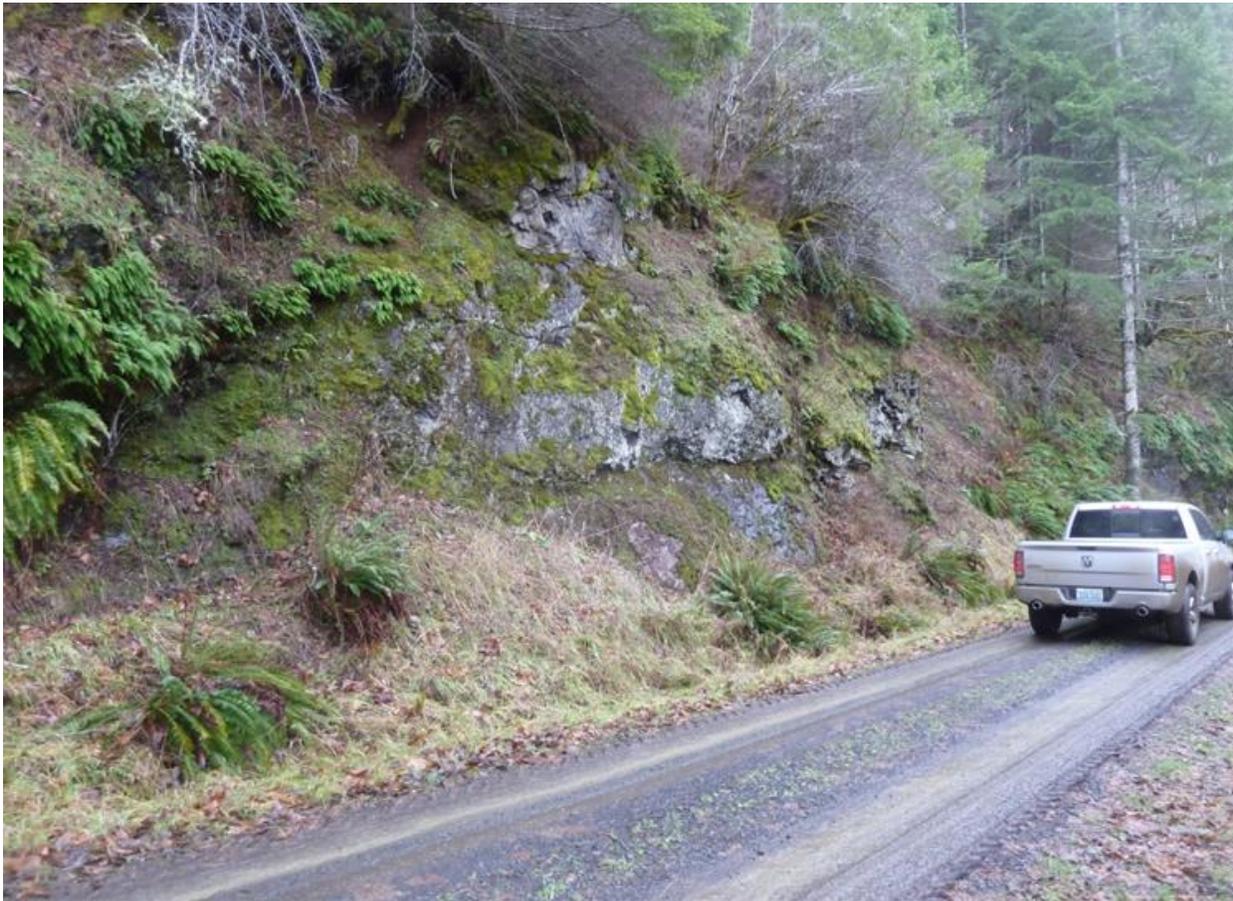
**Photograph 4.3**  
**Basalt Outcrop Along Haul Road Route Bisecting Quarry 1**

basalt to a depth of 114.5 feet giving an estimated mineable thickness of about 80 feet as shown on the composite log found in Appendix E. Beneath the solid basalt was 4 feet of siltstone that would be unacceptable as aggregate material and beneath that to the bottom of the borehole at 150 feet depth was 31 feet of Breccia. The breccia at this location was a mix of basalt and claystone clasts ranging widely in size from 0.1 to 1.6 feet as opposed to the breccia encountered at the dam site where basalt clasts were found in a clear claystone matrix. Two representative sample intervals were selected for lab testing in the basalt from QB-1 and one interval was selected in the breccia to evaluate the suitability as aggregate. The results of the lab testing are discussed in Section 4.3.1 below. A single SRT survey line was completed along the crest of the ridge and passing through QB-1 for correlation and is discussed below in section 4.3.2.

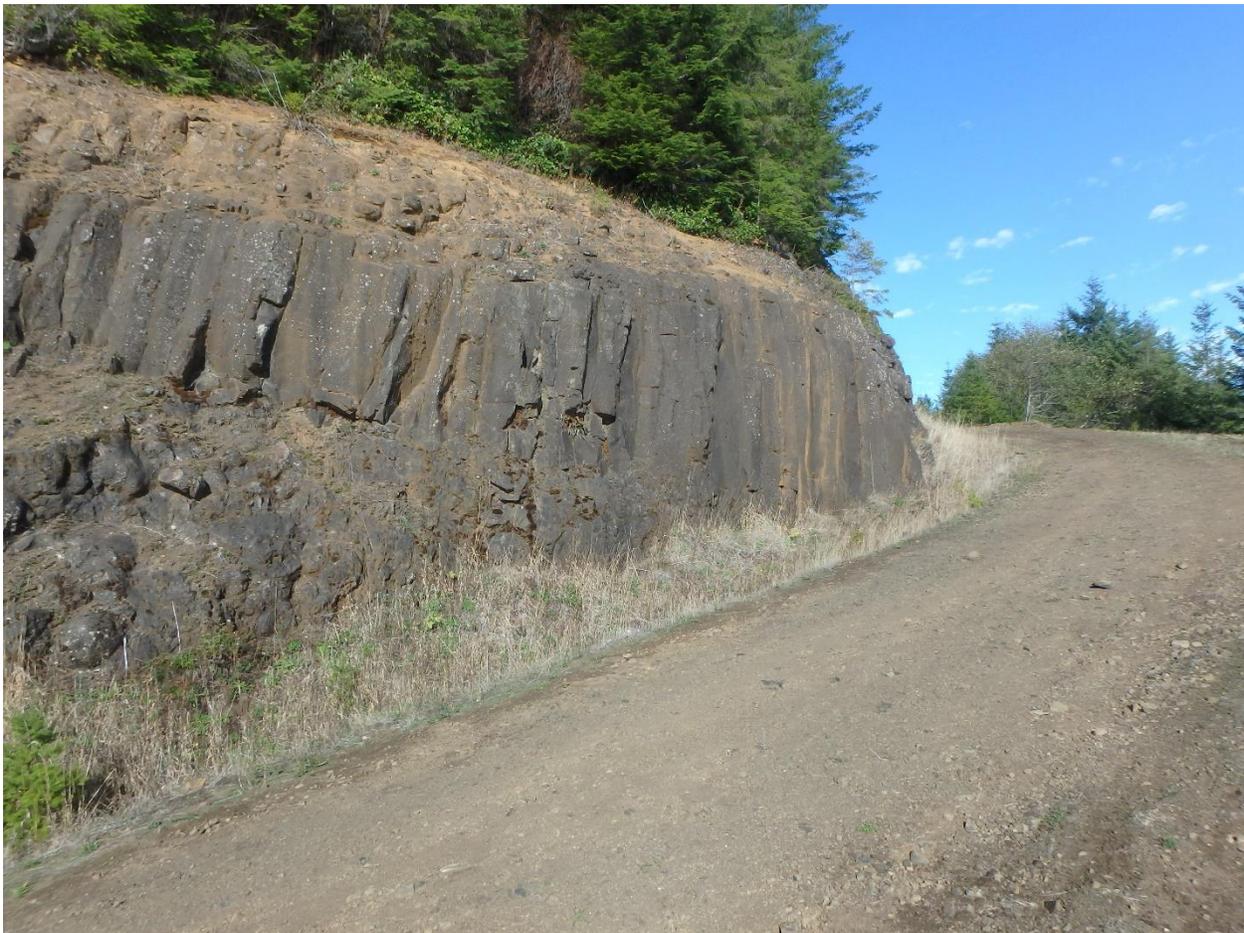
**Photograph 4.4**  
**Rock Outcrop Along Eastern Boundary of Quarry 2**

Quarry 2, shown on Figure 4.11, is located about 7 miles southwest of the dam site. It consists of a less prominent basalt ridge than Quarry 1 trending E-W at an elevation of 2,575 feet, with a steep southern face and easy access from the west on an old logging road off of a main haul road that bounds the north

side of the site. Another haul road, where Photo 4.4 was taken from, bounds the east and southern boundaries of the site. The topography at this site provides plenty of space for the required size quarry without moving any haul roads and the current haul roads are positioned well for easy access. QB-2 was advanced about 10 feet below the ridge crest at about elevation 2,565 feet along the old logging road and encountered no soil overlying. Relatively high quality Crescent formation basalt was found to a depth 94 feet as shown on the composite log found in Appendix E. Beneath the quality basalt to a depth of 131.5 feet was about a 37 foot thick sequence of alternating claystone/siltstone with basalt and basalt breccia in a claystone matrix similar to the breccia encountered at the dam site. From 131.5 feet to the end of the boring at 150 feet was competent basalt. Two representative sample intervals were selected for lab testing in the basalt from QB-2 a. The results of the lab testing are discussed in Section 4.3.1 below. A single SRT survey line was completed from the top of the ridge along the old logging road to the northwest near QB-2 for correlation and discussed below in section 4.3.2.

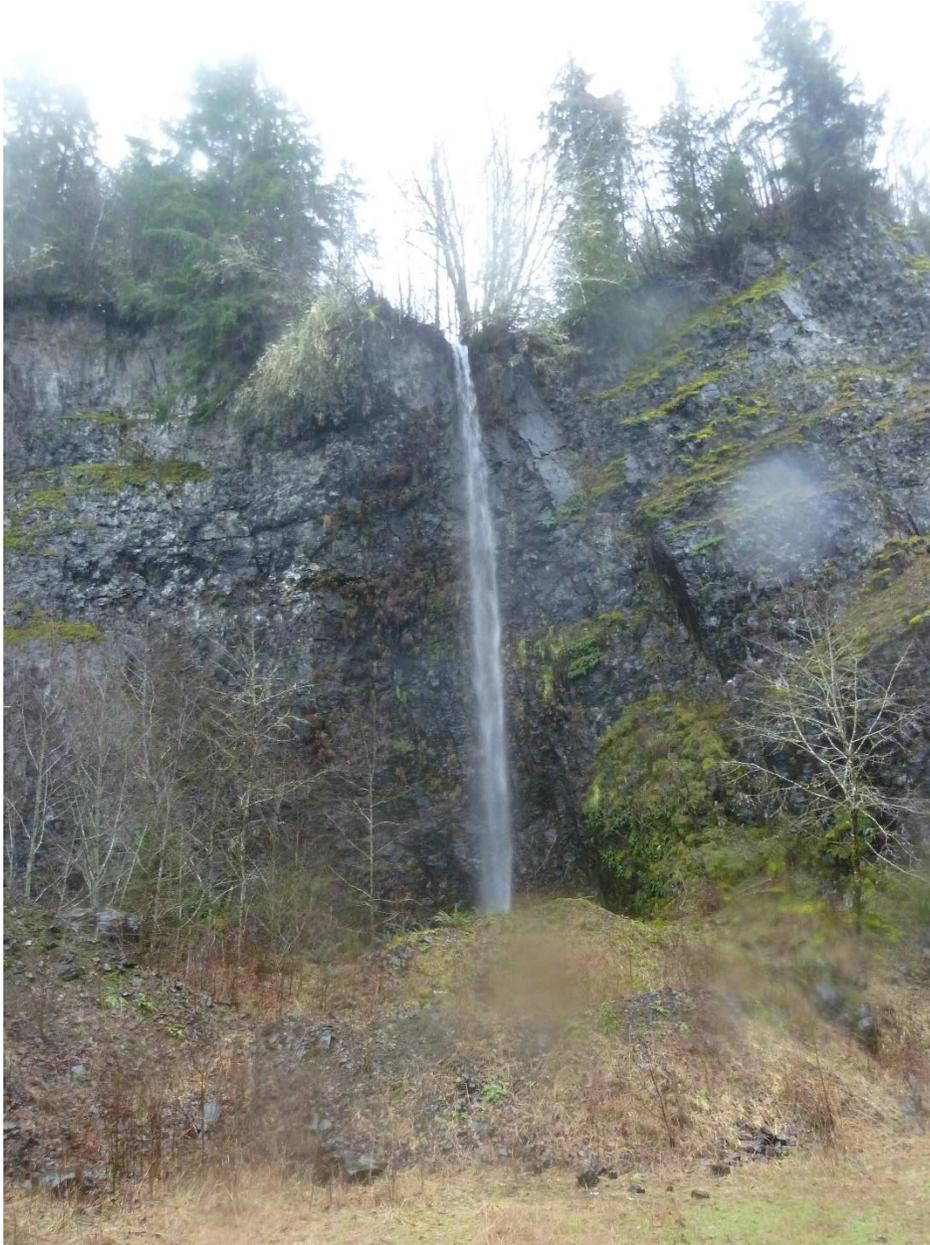
**Photograph 4.5**  
**Rock Creek Spilling over the Old Quarry Face at the Site of Quarry 3**

Quarry 3 (Rock Creek), shown in photo 4.5, is located about 8 miles west of the dam site down the A-line road off highway 6. It consists of about a 30 to 50-foot high rock face forming a rough semi-circle with a large flat access area. Rock Creek spills over the exposed rock face of this existing but inactive quarry and is shown in the photograph. The creek continues north through the site along the A-line road. To avoid the creek Quarry 3 would advance the existing rock face west into a N-S trending ridge that tops out at elevation 1,175 feet. An old logging road exists for easy access to the ridge from the south for future drilling. No borings or SRT survey lines were completed at the Rock Creek site because samples from the rock face were readily available for lab testing and the overburden soil above the face can be seen as minimal.
