Appendix N

Visual Quality Impact Analysis

Chehalis River Basin Flood Damage Reduction Project

NEPA Environmental Impact Statement

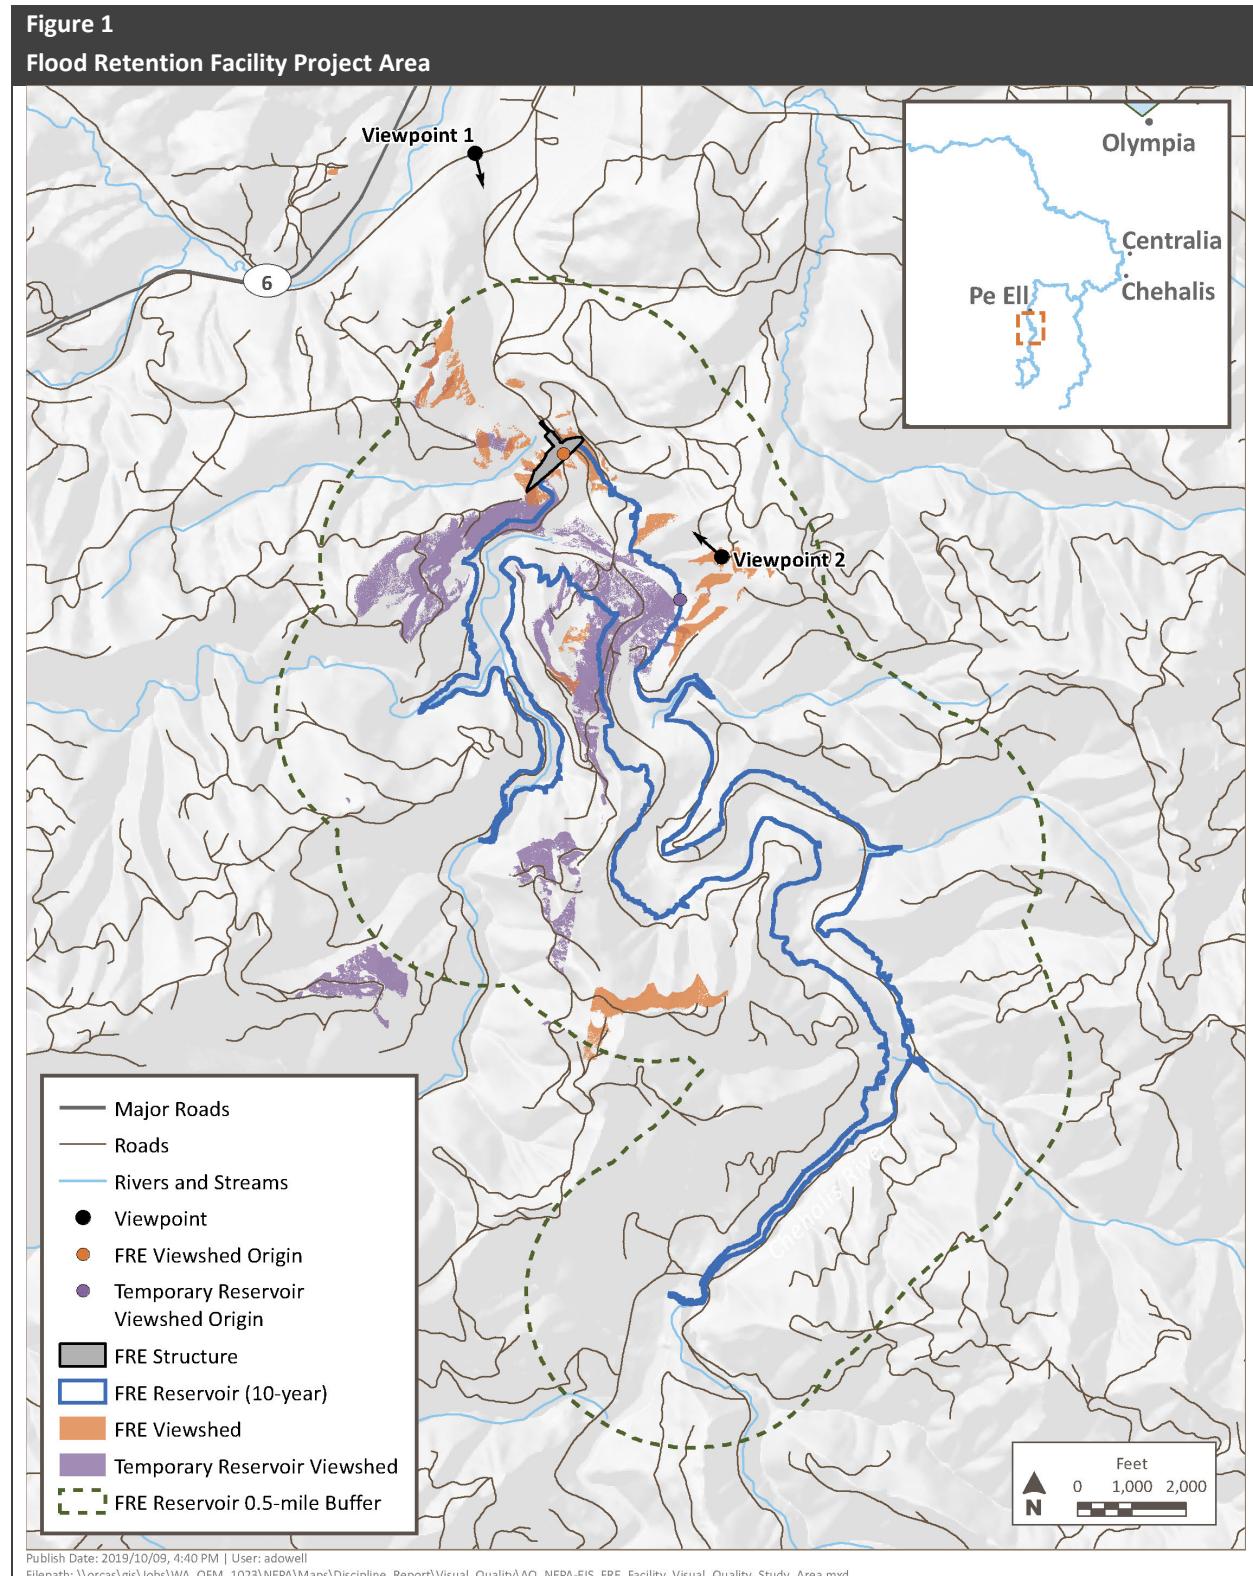
The analysis focused on the places where new facilities would be constructed in the flood retention facility and Airport Levee Improvement project areas. The analysis areas are shown in Figures 1 and 2. Visual changes in the Chehalis River 100-year floodplain area were assessed qualitatively.

In the flood retention facility project area, the analysis found all the places where people would likely be able to see the proposed facilities. This included the places where people would likely be able to see the temporary reservoir. Because the ground surrounding the Chehalis-Centralia Airport is relatively flat, a viewshed analysis was not completed for the Airport Levee Improvements.

Key viewpoints were identified based on the viewshed analysis and an understanding of how people use the study area. Although the proposed project changes could be visible from other points within the viewshed, three key viewpoints were chosen as representative. This includes two at the proposed flood retention facility location (Viewpoints 1 and 2 in Figure 1). Based on the viewshed analysis and field visits, it was determined that the proposed project changes would not be visible from Viewpoint 1. Viewpoint 1 was originally selected because it is along a popular hiking trail, the Willapa Hills Trail. Viewpoint 2 was selected because it is within an area where the public may be granted access by permit. The viewpoint at the Chehalis-Centralia Airport was selected because it is from the Riverside Golf Club where people may be more sensitive to visual changes (Viewpoint 3 in Figure 2).
